RESIDENTIAL REPORT

1234 Main St.
Lancaster PA 17603

Buyer Name
03/22/2018 9:00AM

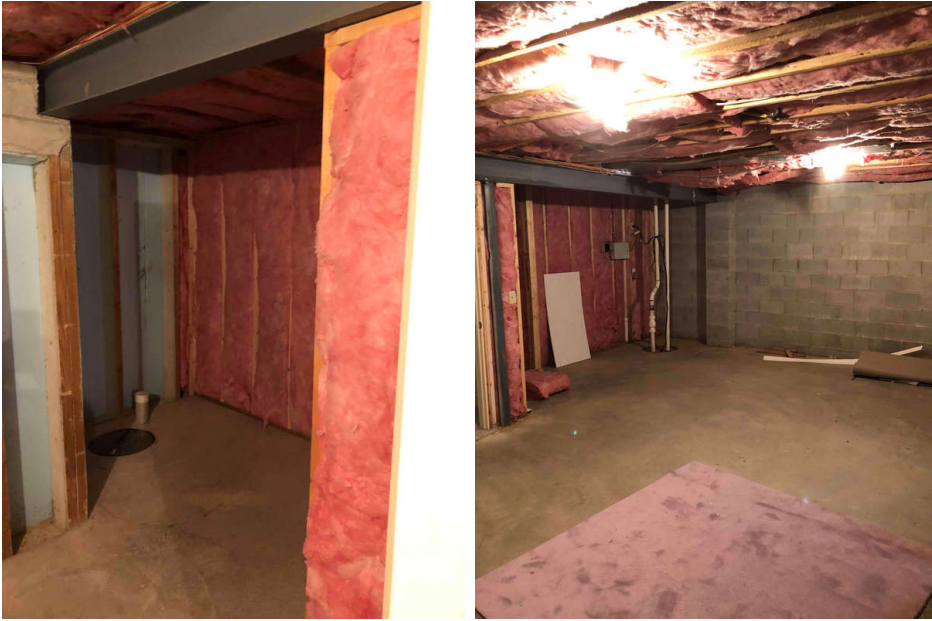
Foundation Structure: Structure and material

At the time of inspection the foundation structure and material appeared to be in good condition. Any specific defects will be listed in the report.

Foundation Structure: Type

full basement

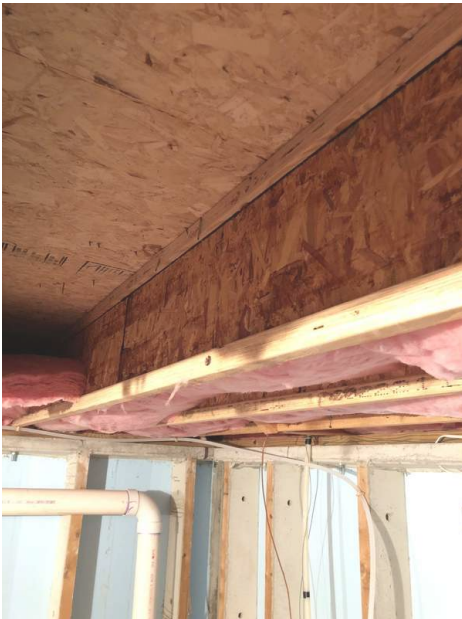
**Floor Structure: Floor Structure and Material**

OSB, Wood I-joist

Because of interior floor and ceiling coverings, not all floor structural members were able to be inspected. At the time of inspection, the floor structure and material appeared to be in good condition. Any specific defects will be listed in the report.

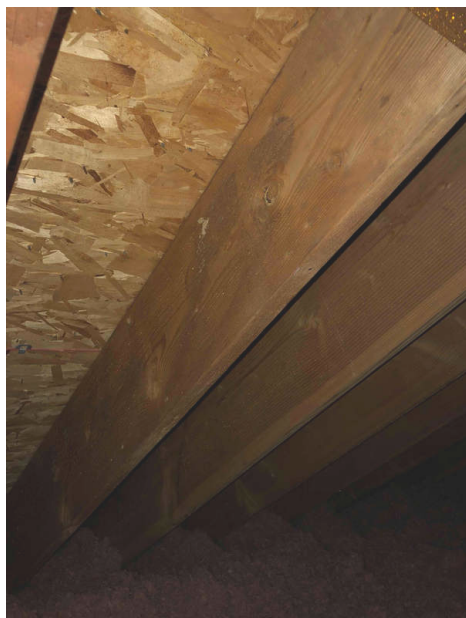
OSB, Wood dimensional

At the time of inspection the roof and attic structure and material appeared to be in good condition. Any specific defects will be listed in the report.

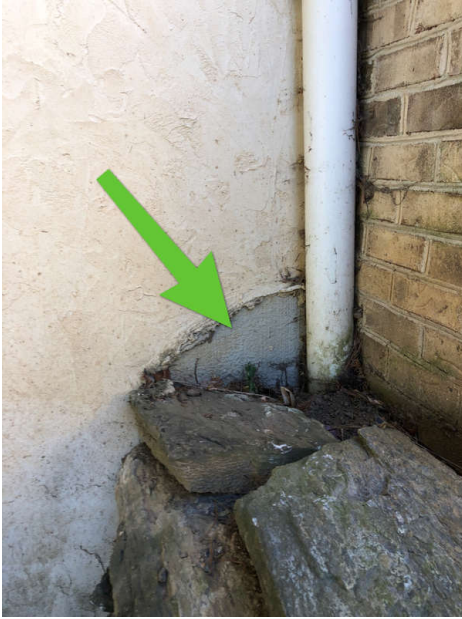
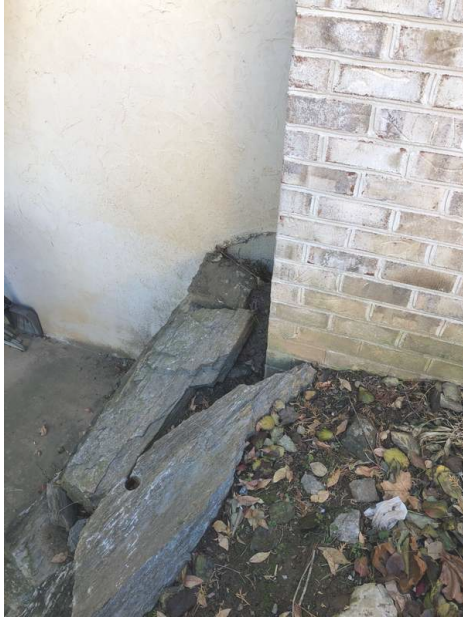
Superior wall

Foundation Wall Exterior: Foundation exterior OK

At the time of inspection the exterior foundation wall appeared to be in good condition. Any recommendations will be listed separately in the report.

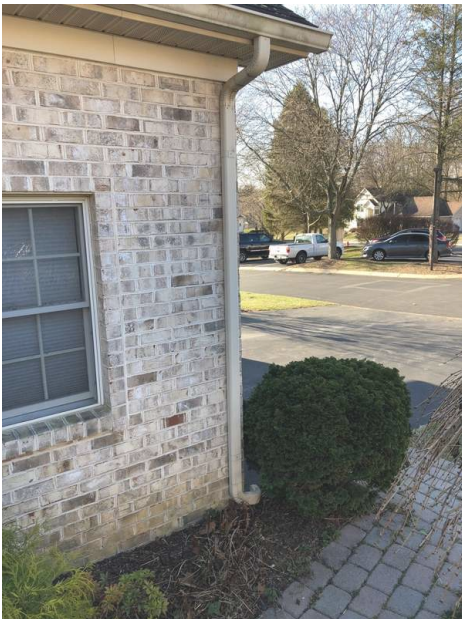
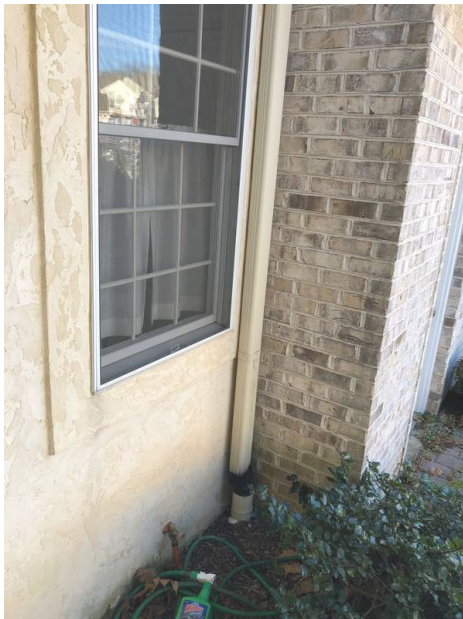
Grading and Drainage: Drainage systems

Gutter to grade, Gutter to piping

At the time of inspection the drainage appeared to be in good condition. Any recommendations will be listed separately in the report.

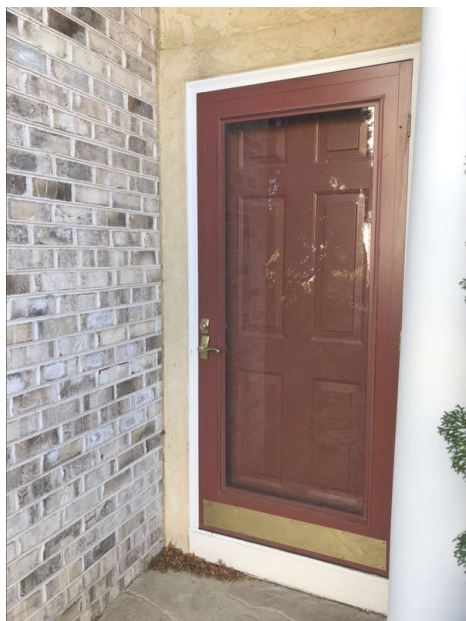
Front door

Exterior Doors: Exterior Entry Door

Steel

At the time of inspection the exterior entry door appeared to be in good condition. Any recommendations will be listed separately in the report.

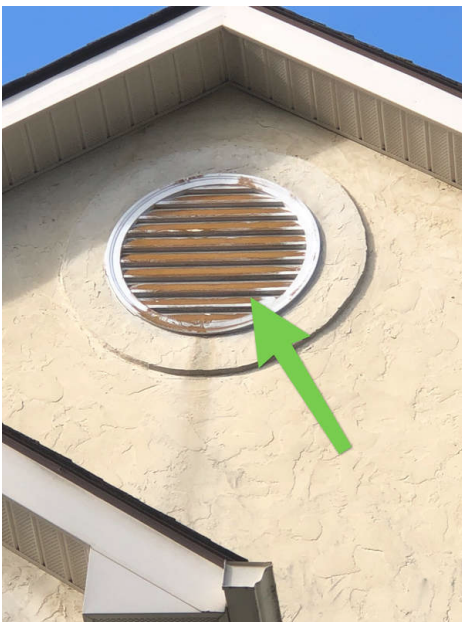
Back louver

Exterior Paint: Painting needed -minor

At the time of inspection the exterior wood surfaces showed moderate signs of wear. I recommend a qualified professional to evaluate and paint in order to preserve the wood.

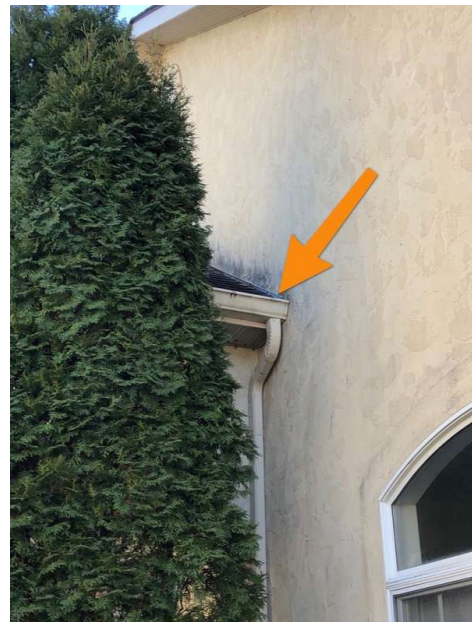
Comments**5.2.1 Siding, Flashing & Trim****Recommendations****EVIDENCE OF WATER INTRUSION**

Siding showed signs of water intrusion. This could lead to further siding deterioration and/or mold. Recommend a qualified siding contractor evaluate and repair.

Contact a qualified siding specialist.

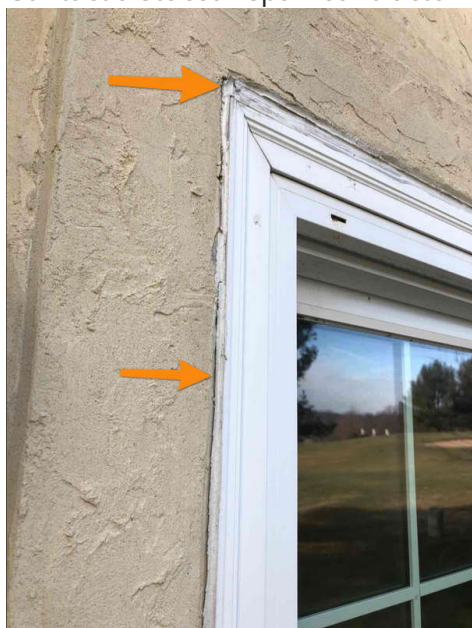
5.2.2 Siding, Flashing & Trim

MINOR STUCCO CRACKING

At the time of inspection the stucco exterior showed signs of cracking. This can cause daage to the substrate. Hidden damage may exist. Moisture can become trapped behind stucco and can cause moisture problems to the wood framing behind the stucco or crack the stucco. I was unable to determine if the stucco was applied at the proper thickness, if the wall penetrations were properly flashed, or if the wall sheathing was properly wrapped prior to stucco installation to prevent moisture damage to the sheathing behind. Cracking was noted in many locations. I recommend a qualified professional to evaluate and recommend repairs.

Back

Contact a stucco repair contractor

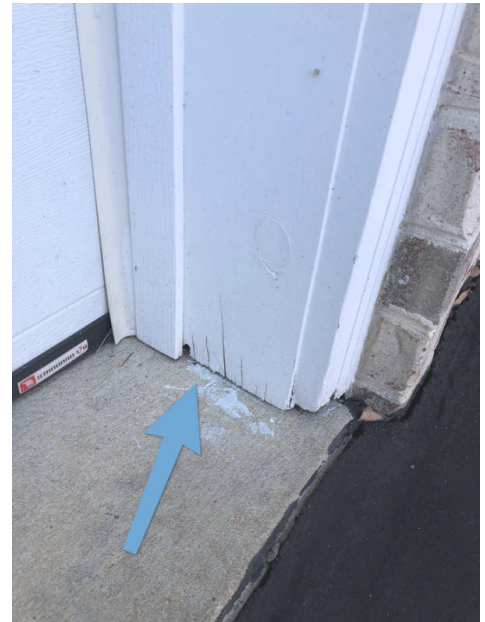
At the time of inspection I found signs of minor rotten wood trim. Recommend patching and painting or covering with maintenance free material.

Front

Contact a qualified carpenter.

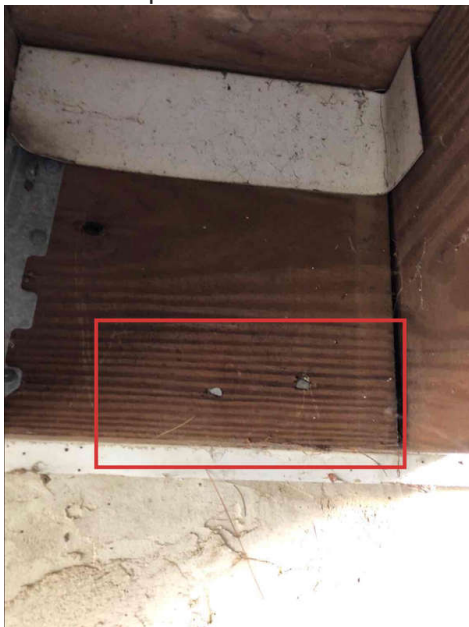
5.8.1 Decks, Balconies, & Steps

At the time of inspection the deck ledge did not appear to be attached properly to the house. Deck ledger should be designed to resist 3,000 lb. lateral load (force pulling away from ledger) in order to prevent collapse. I recommend a qualified professional evaluate and repair as necessary.

only nails are visible

Contact a qualified deck contractor.

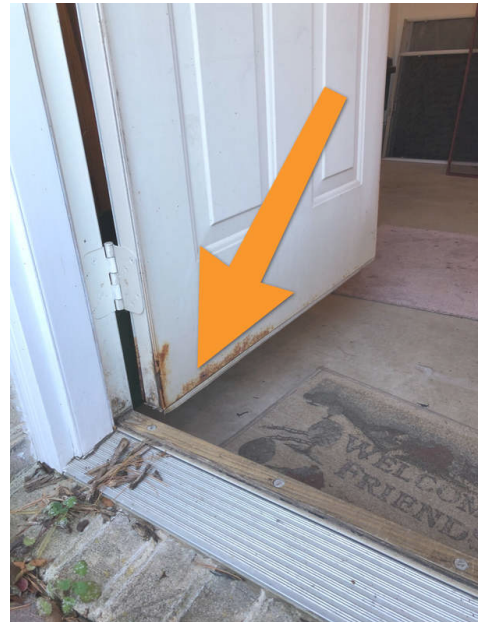
RUSTED METAL DOOR

At the time of inspection the side garage door was rusted and swelled at the bottom. The door is failing to seal properly and is vulnerable to penetration by force or moisture. I recommend a qualified professional to evaluate and replace the door.

Garage door

Contact a qualified carpenter.

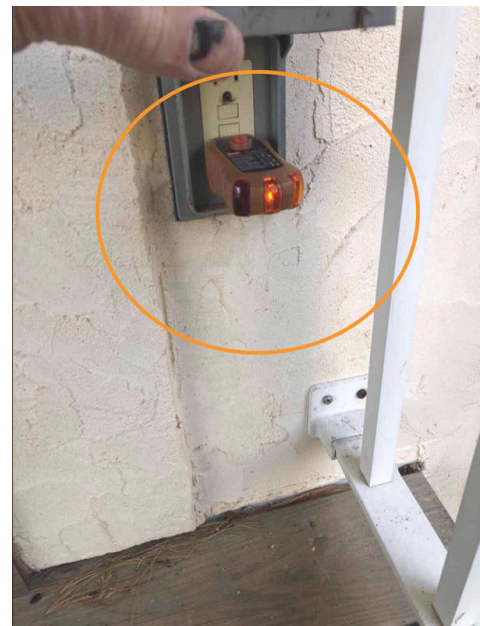
5.11.1 Exterior GFCI's

GFCI OUTLET(S) DEFECTIVE

At the time of the inspection, I observed one or more Ground Fault Circuit Interrupters (GFCI) did not respond to testing, did not re-set, was slow to re-set or made a buzzing sound when re-set. This indicates that the condition of GFCI(s) is deteriorating and presents a safety issue. I recommend the replacement of the failed receptacle(s) by a qualified professional to ensure proper functioning.

deck porch

Contact a qualified electrical contractor.

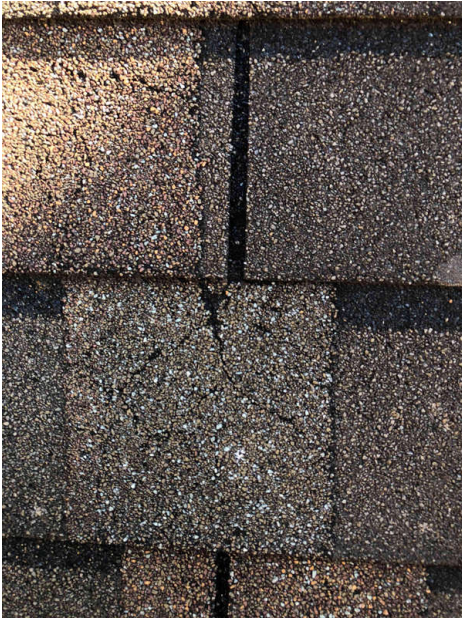
Coverings: Material

Fiberglass

At the time of inspection the roof material seemed to be in good condition. I recommend monitoring for future damage and or leakage. Any defects will be listed separately in the report.

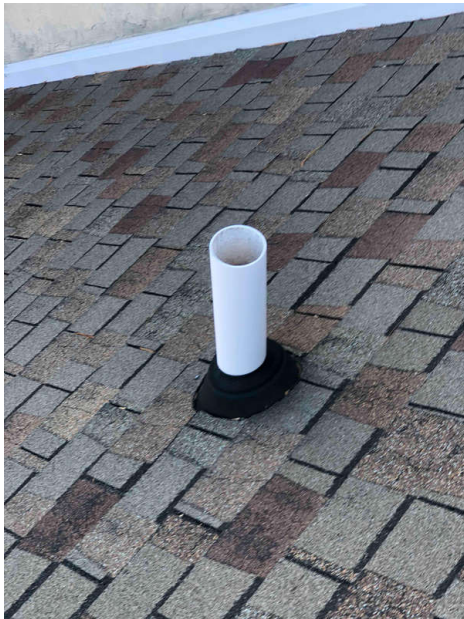
At the time of inspection the roof penetrations appeared to be in good condition. Any recommendations will be listed separately in the report.

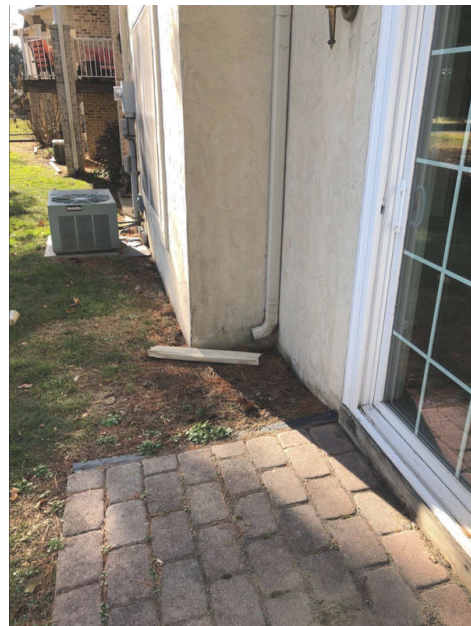
6.2.1 Roof Drainage Systems

One or more downspouts drain too close to the home's foundation. This can result in excessive moisture in the soil at the foundation, which can lead to foundation/structural movement. Recommend a qualified contractor adjust downspout extensions to drain at least 6 feet from the foundation.

Back

Contact a qualified roofing professional.

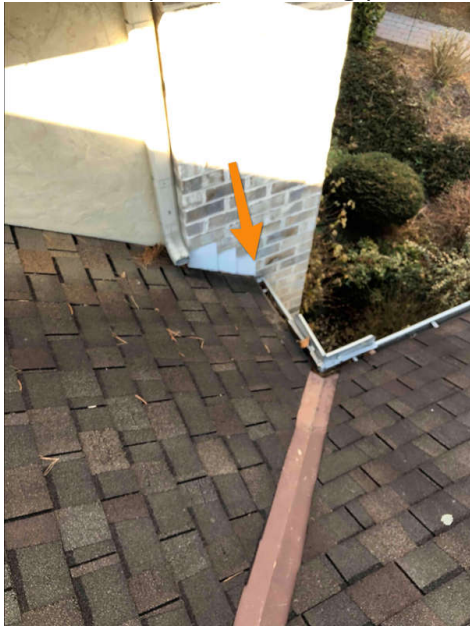
6.3.1 Flashings

KICKOUT FLASHING MISSING

- The need for kickout flashing developed fairly recently and the builder may not have been aware that one was required.
- Kickout flashing is critical anywhere a roof and exterior wall intersect and where the wall continues past the lower roof-edge and gutter.
- If a kickout flashing is absent in this location, large amounts of water may miss the gutter, penetrate the siding, and become trapped inside the wall causing damage.

above deck porch

Contact a qualified roofing professional.

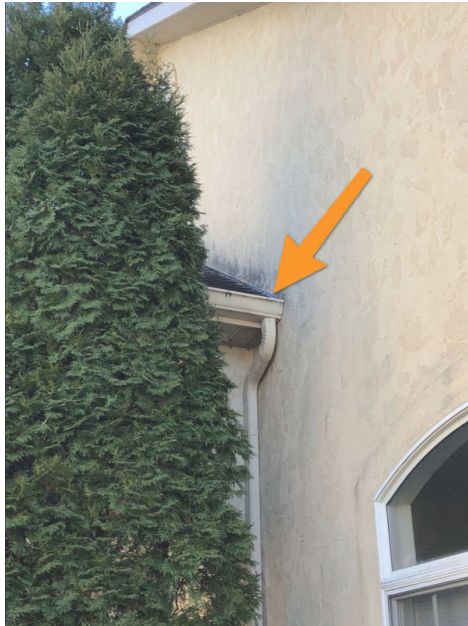
Side

At 22 years, the roof appeared to be at the end of its life. Significant wear was evident. I recommend a qualified professional to evaluate and replace the roof in 1-5 years.

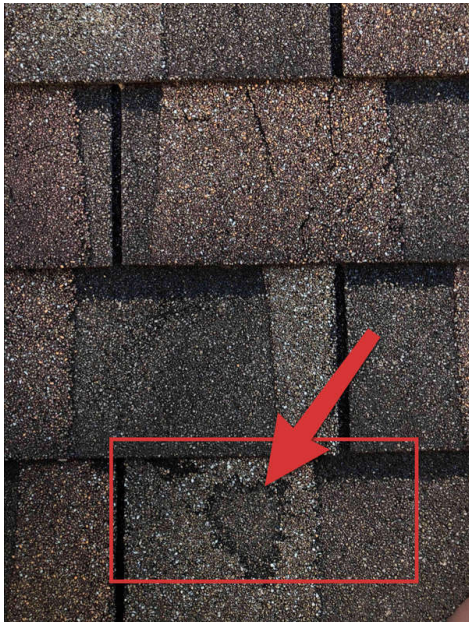
wear spot

Contact a qualified professional.

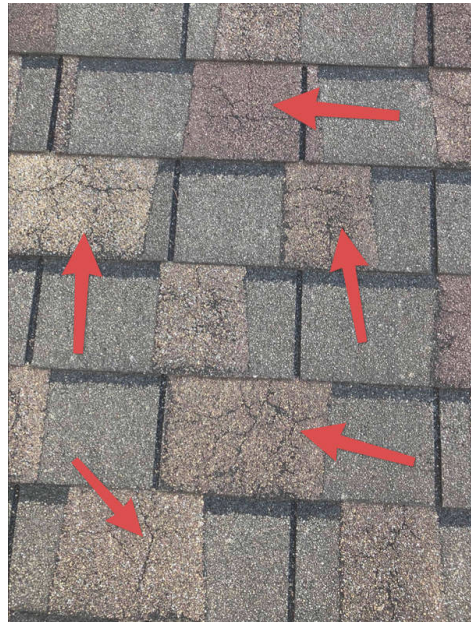
cracking shingles

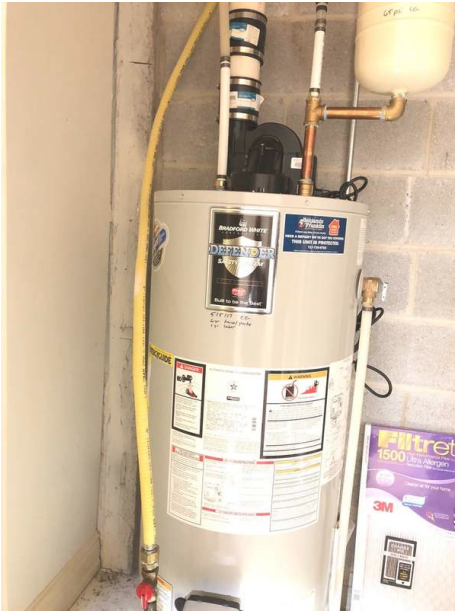
Water Heater: Power Source
Gas

Water Heater: Location
Basement

40 gal

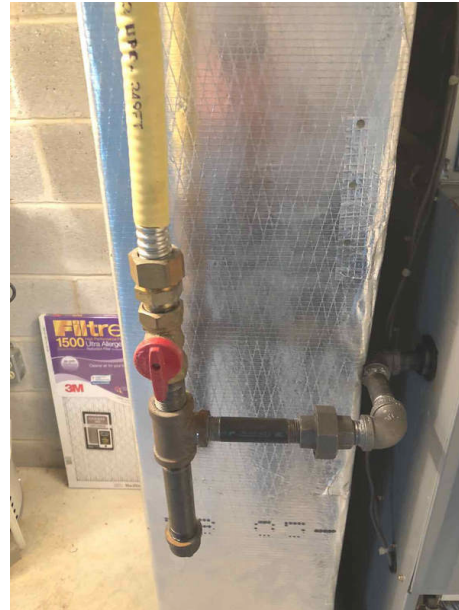
CSST, Black Pipe

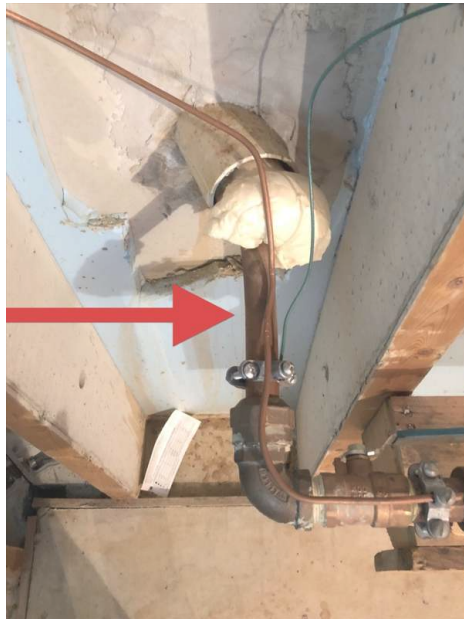
Underground pipes or pipes inside walls cannot be judged for size, leaks or corrosion. Hidden damage may exist.

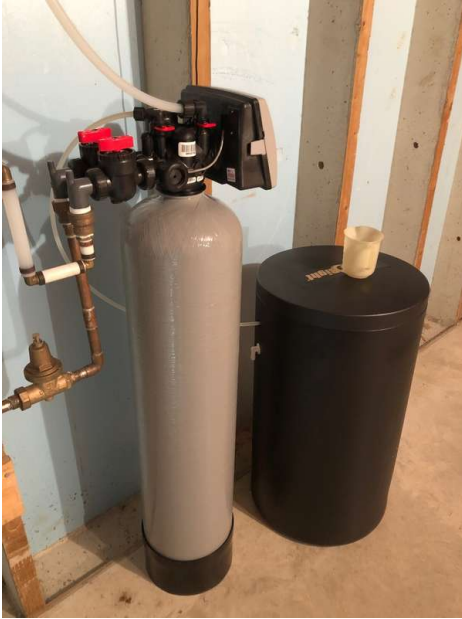
The condition or functionality of the water conditioning systems were not part of the home inspection and were not evaluated. These systems require periodic maintenance. I recommend a complete evaluation by a licensed water treatment contractor.

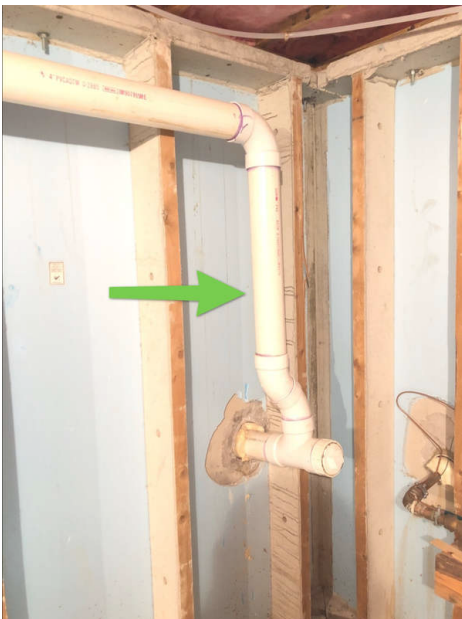
main soil line

At the time of inspection the drain, waste and venting systems seemed to be functioning adequately. Any specific defects will be listed in the report.

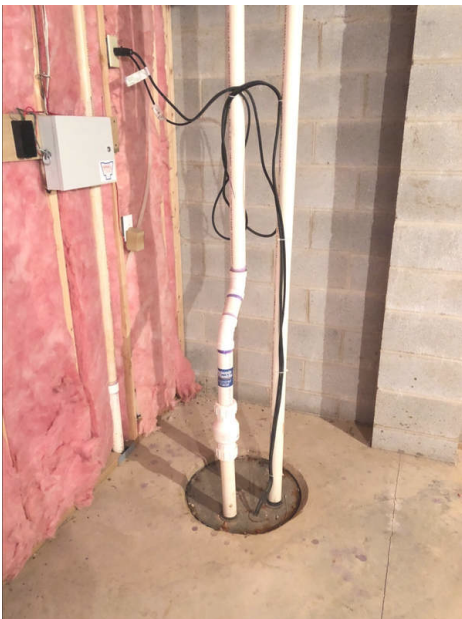
At the time of inspection the sewage ejector pump appeared to be operational at the time of the inspection. Any defects will be listed separately in the report.

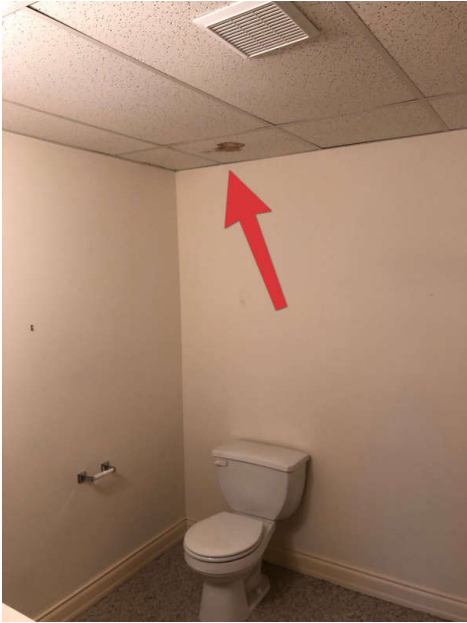
Basement Bathroom

At the time of inspection I observed an active water leak beneath the 1st floor shower stall. Moisture damage can progress quickly and cause significant damage. I recommend a qualified professional evaluate and repair the leak(s).

Contact a qualified plumbing contractor.

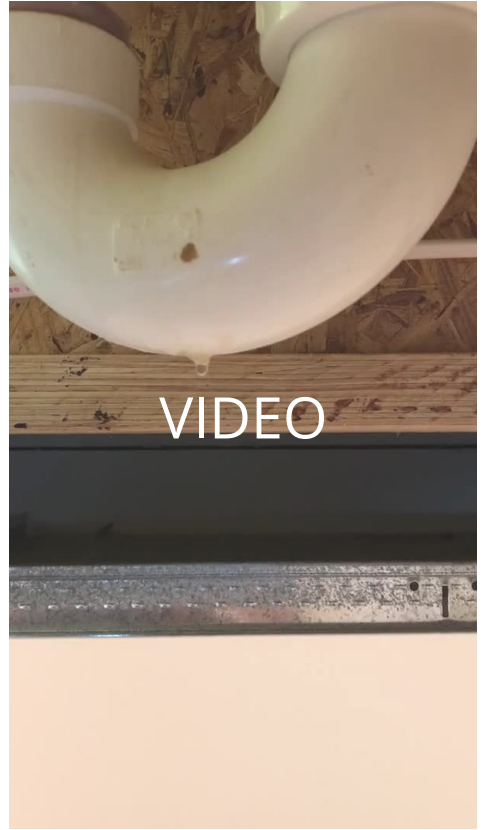
ACTIVE LEAK

1st Floor shower stall

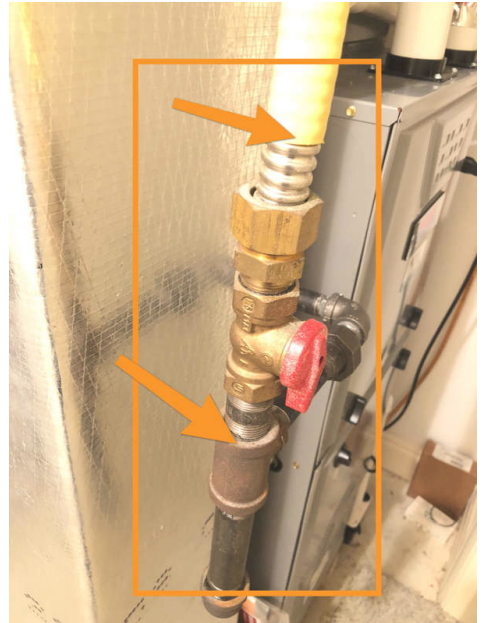
7.7.1 Fuel Supply, Storage & Distribution Systems

The CSST gas piping did not appear to be properly bonded. CSST gas piping may be vulnerable to damage during a lightning storm if not properly bonded. A licensed electrician is recommended to evaluate and properly bond the gas piping as necessary.

Bond to ground

Contact a qualified electrical contractor.

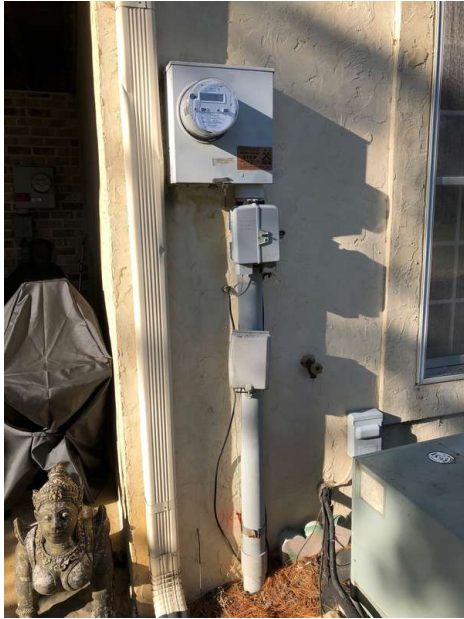
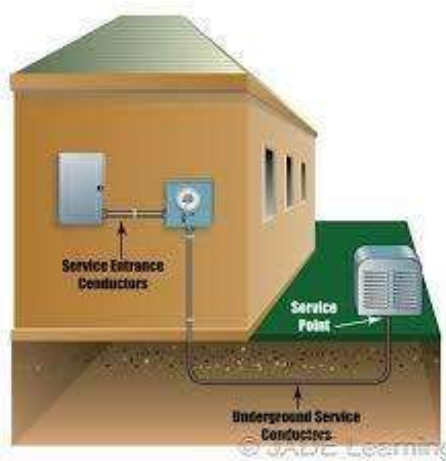
Typical Underground Service

At the time of inspection the service conductors appeared to be in good condition. Any defects will be listed separately in the report.

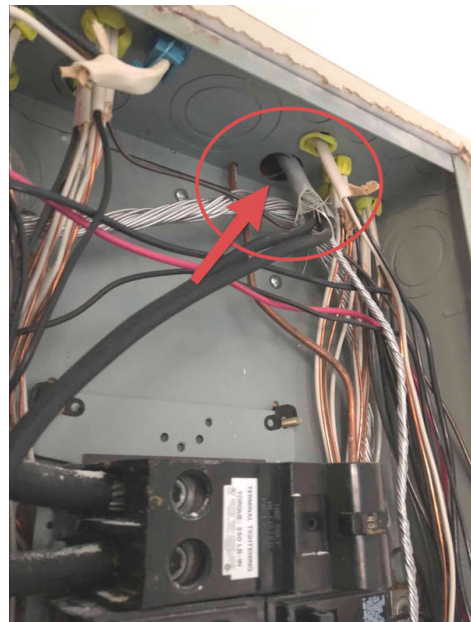
MISSING WIRE BUSHING

At the time of inspection there was one or more missing wire bushing at the main panel. This is a potential fire hazard because the wire could rub against the sharp panel housing and cause sparking. I recommend a qualified professional to install a new bushing.

Contact a qualified electrical contractor.

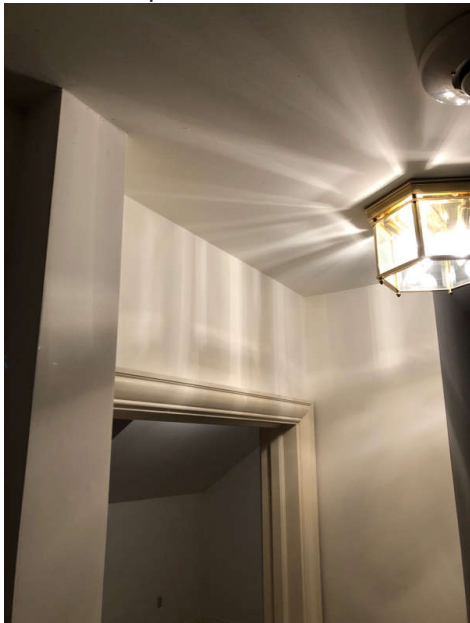
CO DECECTOR MISSING

***Safety* --** At the time of the inspection, there were carbon monoxide detectors missing in the hall outside the bedrooms. Carbon monoxide is a toxic gas that can cause injury or death. Without a CO detector, high levels of carbon monoxide cannot be detected. I recommend installing a CO detector outside all sleeping areas.

Outside bedroom in hall

Contact a qualified electrical contractor.

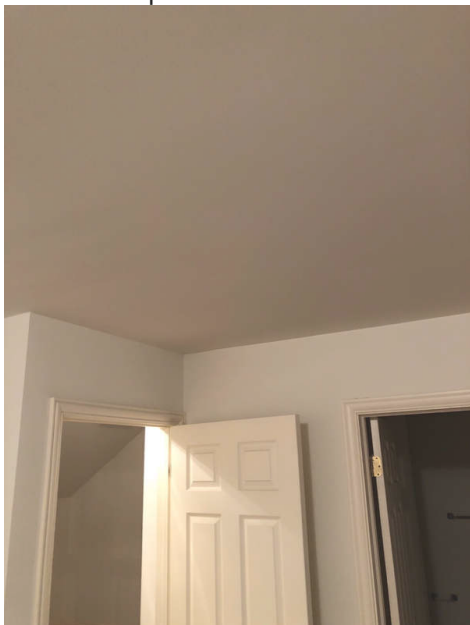
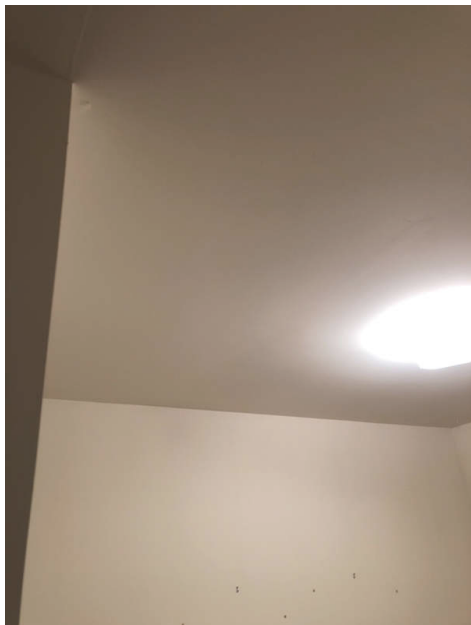
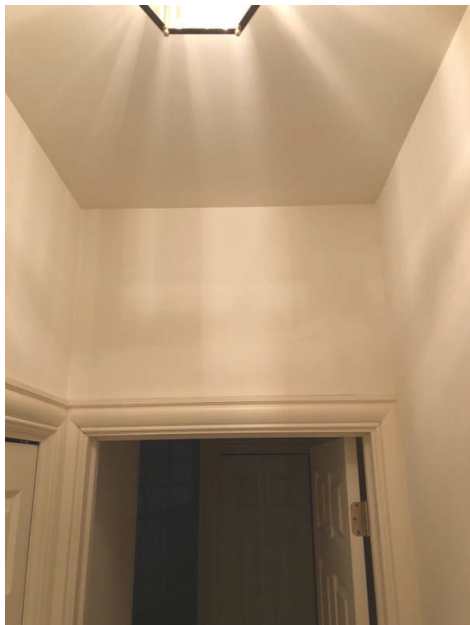
SMOKE DETECTOR(S) MISSING

***Safety* --** At the time of the inspection there were smoke detectors missing in areas that are now required to have smoke detectors installed. I recommend a qualified professional evaluate and install smoke detectors where they are missing.

2nd Floor Bedroom

Contact a qualified electrical contractor.

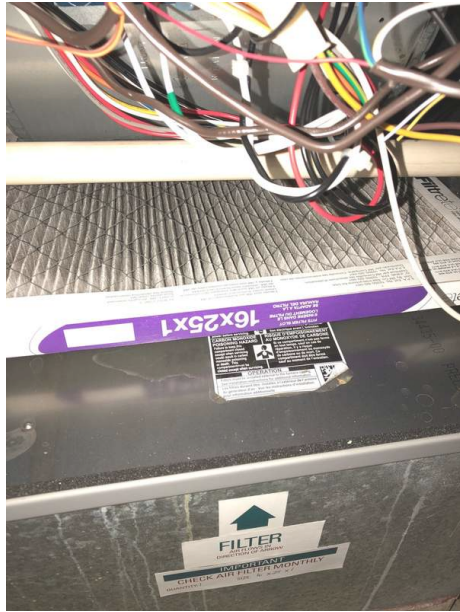
Heating Equipment: Filter size

16x25x1

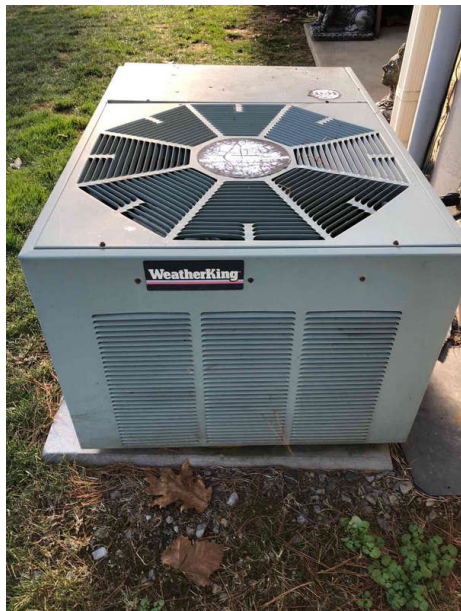
At the time of inspection the A/C condensor unit was found to be 21 years old. The average replacement life of a unit is 15 years. I recommend budgeting for a new condensor unit in the next 1-3 years.

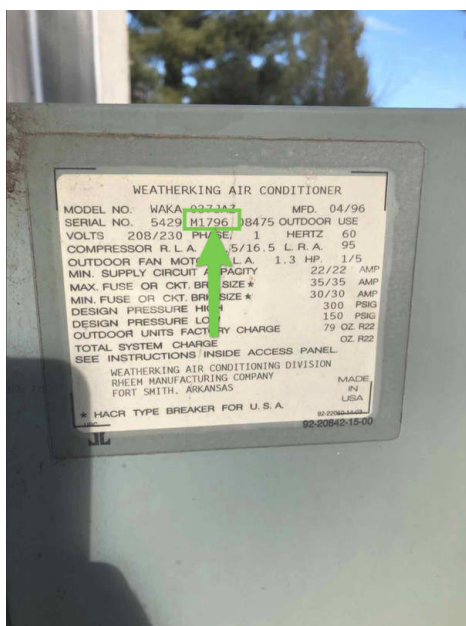
Nearing end of life

April 1996

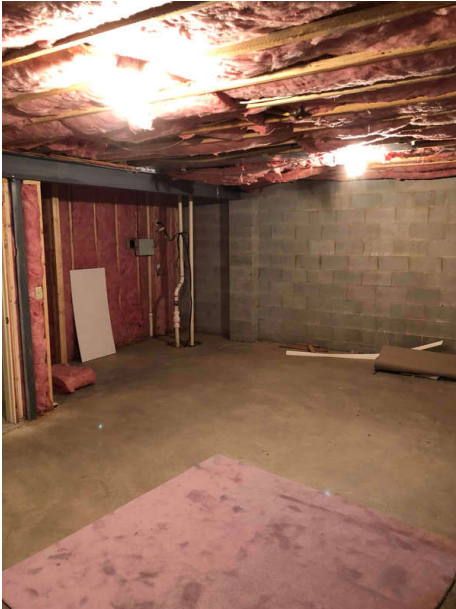
Visual inspection limited

The insulation appeared to be present and properly installed. Not all unfinished spaces were accessible in order to inspect. Insulation could be missing or damaged. Any defects will be listed separately.

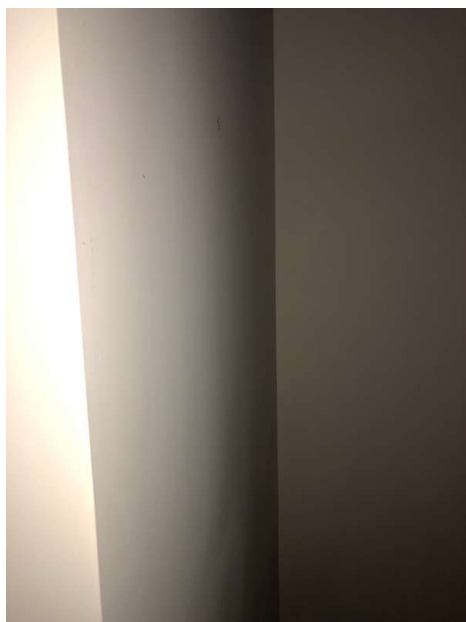
Drywall

At the time of inspection the walls appeared to be in good condition. Any defects will be listed separately in the report.

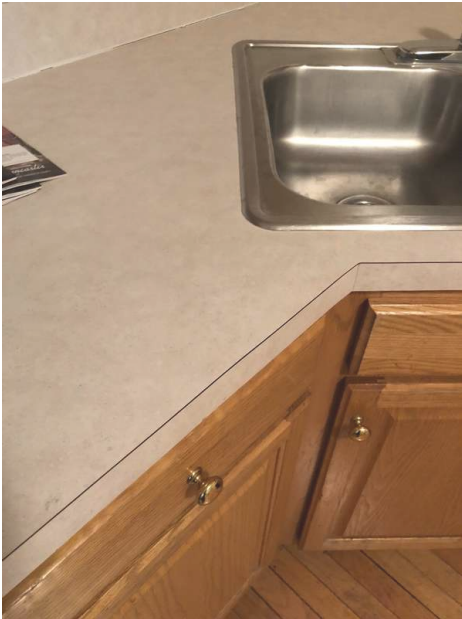
Laminate

At the time of inspection the countertops appeared to be in good condition. Any defects will be listed separately in the report.

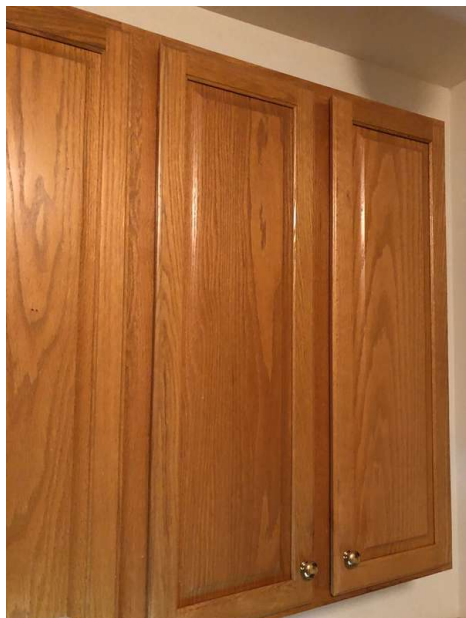
Countertops & Cabinets: Cabinetry

Wood

At the time of inspection the cabinets appeared to be in good condition. Any defects will be listed separately in the report.

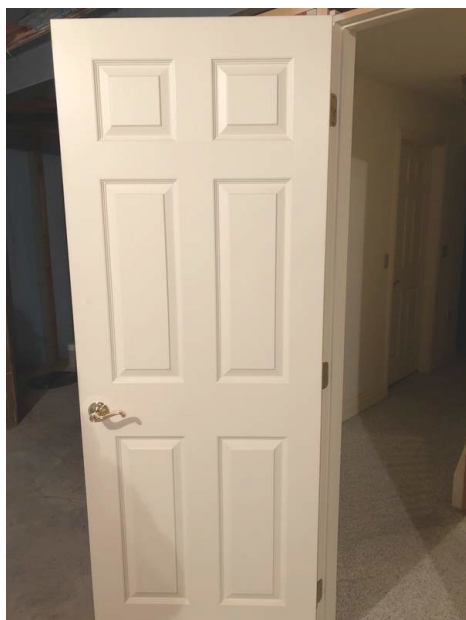
**Doors: Type**

Hollow core panel

At the time of inspection the interior doors appeared to be in good condition. Any recommendations will be listed separately in the report.

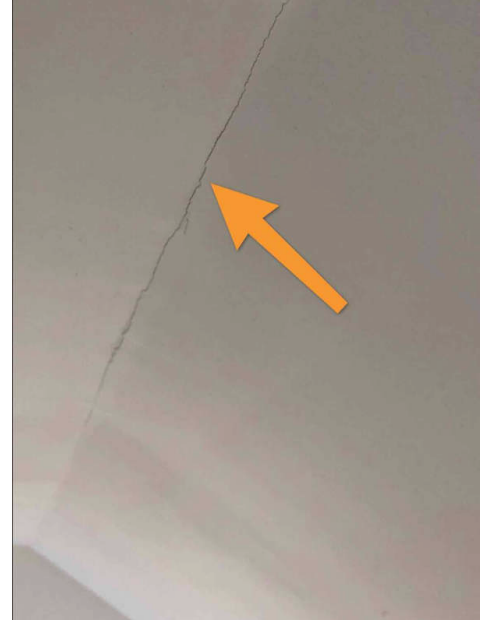
CRACKING IN CATHERDRAL CEILING

cathedral ceiling dining room

Contact a qualified drywall contractor.

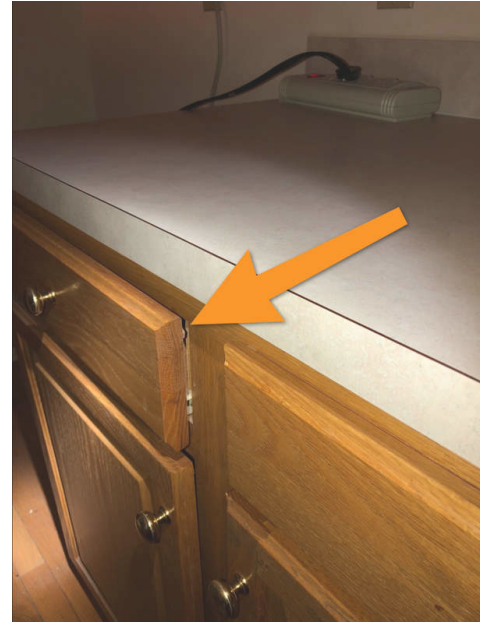
At the time of inspection one of the kitchen drawers was not seating properly. I recommend a qualified professional to evaluate and repair.

Contact a qualified carpenter.

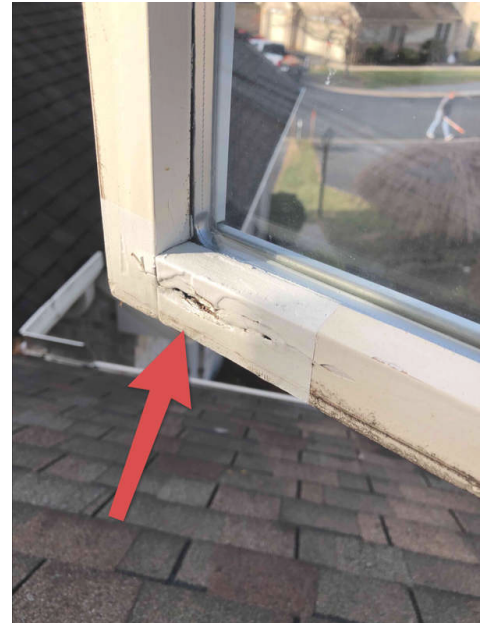
12.7.1 Windows

At the time of inspection the one or more sash appears to rotten, but are operational. Further deterioration will affect the operation of the window. I recommend a qualified professional to evaluate and replace with a new window.

Contact a qualified window repair/installation contractor.

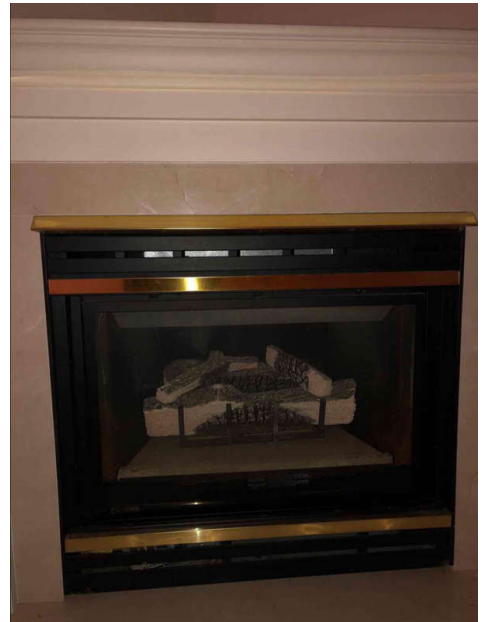
At the time of inspection I could not get the gas fireplace to operate. It appeared that the gas was on but the pilot would not stay on. I recommend a qualified professional to evaluate in order to make the fireplace operational.

Contact a qualified professional.

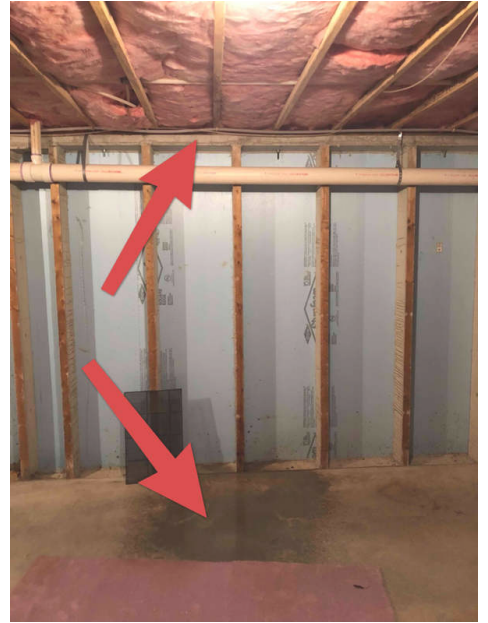
Evidence of leak

Contact a qualified plumbing contractor.
